Repair Autocom CDP VCI

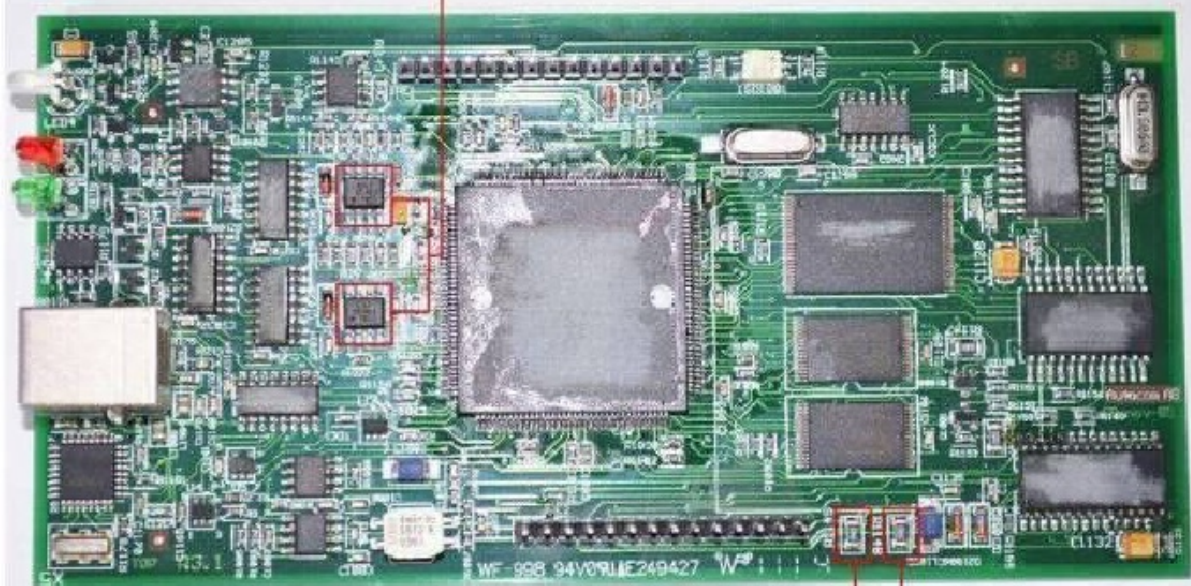
2. check/replace poor quality **Vishay** or **SI9241** K-line transceivers > **9241A**:

Was that car k-line or canbus? Some devices had problem with connection over k-line. If k-line network, you can try to repair it.

remove and change with the 9241A

-change R1148 and R1149 resisitors with 390 Ohm Ω resistor (DIP OR SMT)

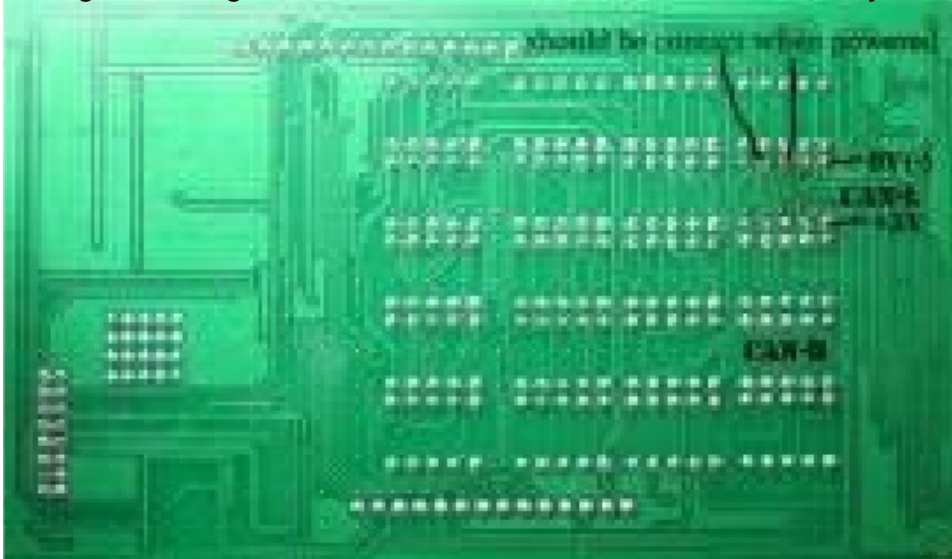
Check voltage on K and L line with multimeter. On idle you must have about **12V** on them. When you start communication with car lines shortly go down on about 1V. If you don't get that voltage drop try to check signal on TX input of **9141 IC**. If you have some pulse (i think from **-5V** to **5V**)

during initializing of connection with car then **9241 IC** is surely defective

maybe transceiver is ok, change 3.9 or 39 ohm > **560 ohm** on pull-up resistor of **SI9241** (or **470 ohm** up to **1 Kohm**)

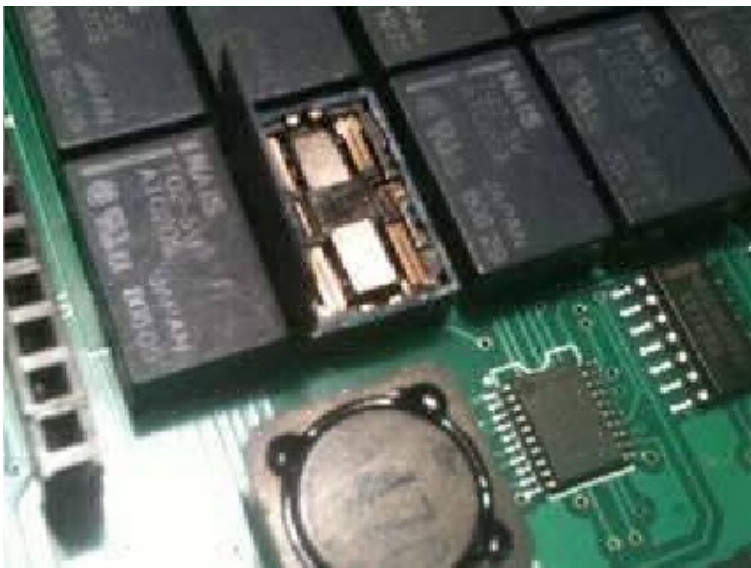
bad K-Line communication: 1 relay in relay board freeze to position "ON". open the relay with a knife and I set the weight inside the spring to automatically switch to the OFF position

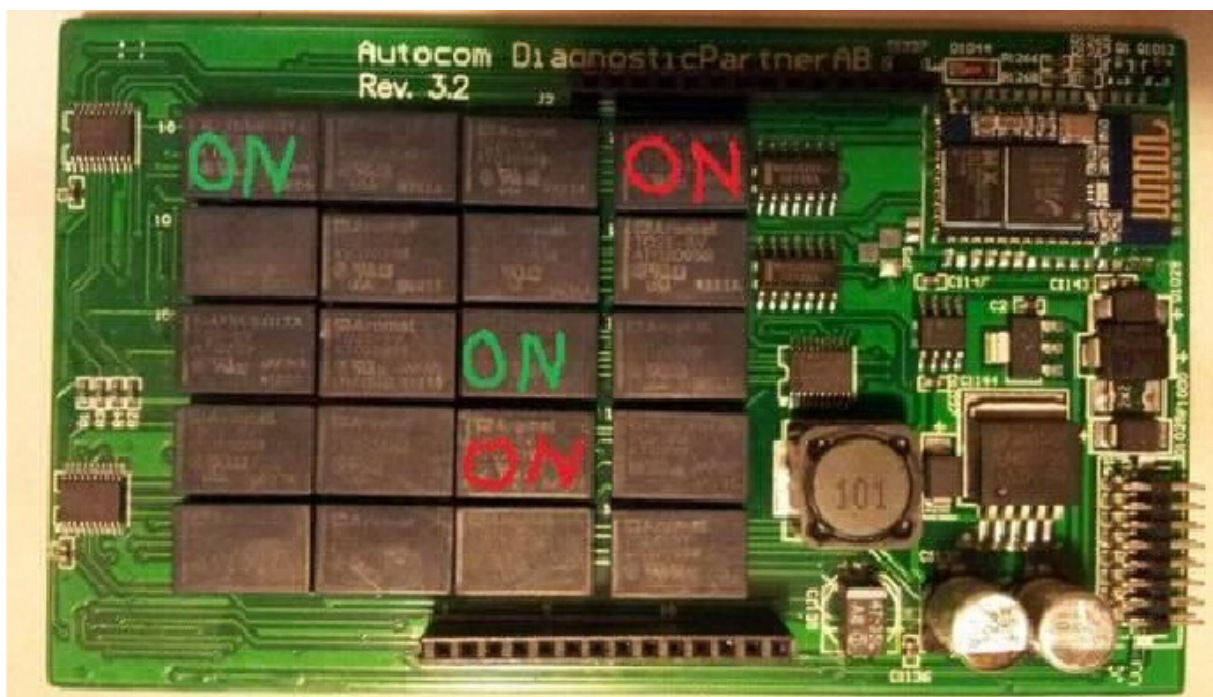
When CDP powered and connected to USB, run SW and connect to any car (no need for a real car!) and then go back to main SW window. measure relay coils and see how many are ON: 3 relays must be ON when in this window! If only 2 are ON BMW E60 and E90 don't work!

only 2 red marked must be ON when standby, both 2 red and 2 green marked (1 relay for obd pin 1 and 1 relay for obd pin 7 and 15) must be ON with bmw

replace relays drivers ic's **LV125D** > **NPX 74LV125D**

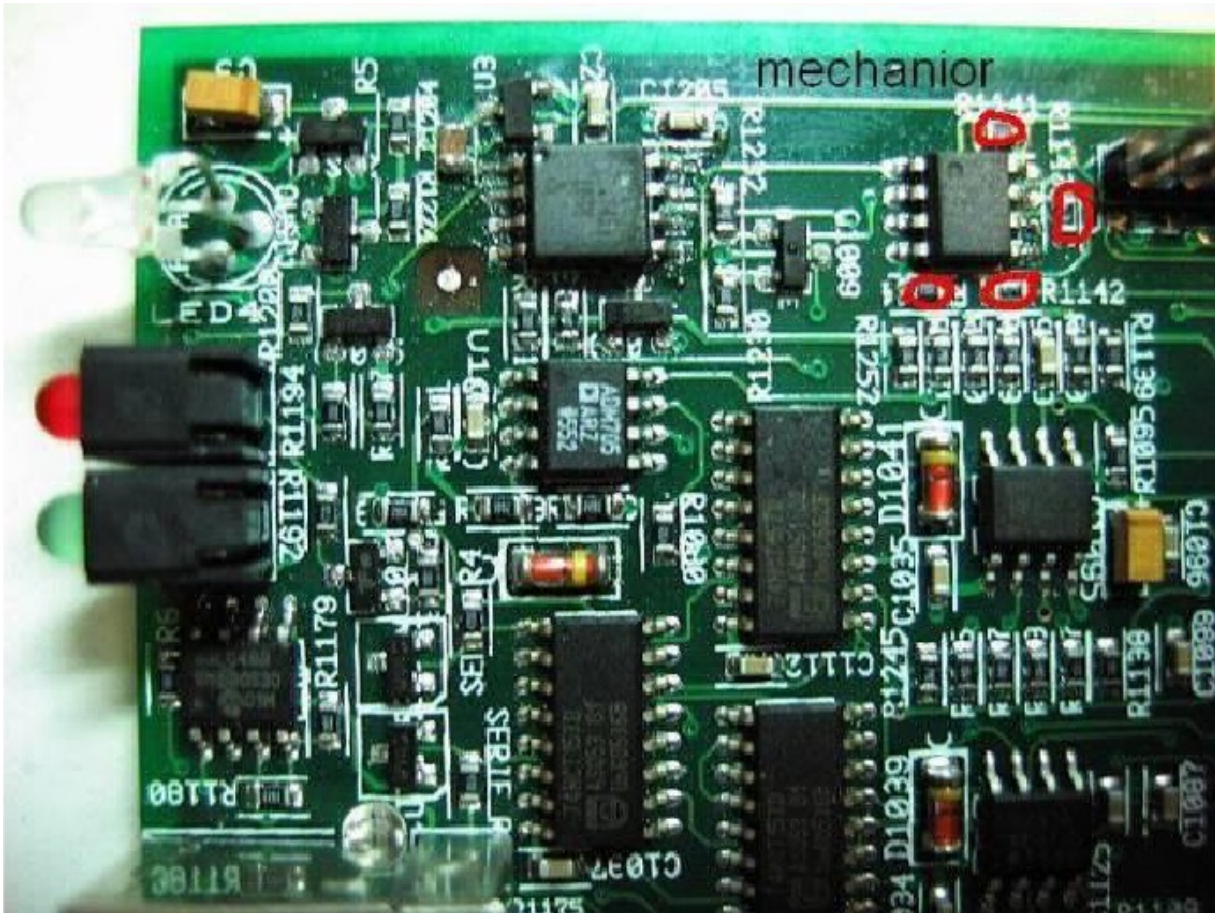
8. check/replace 4 resistors together max1487: **R36 (R1143)** 47 Ohms, **R34 (R1144)** 10K, **R33 (R1141)** 10K, **R35 (R1142)** 10K or 470 ohms ???

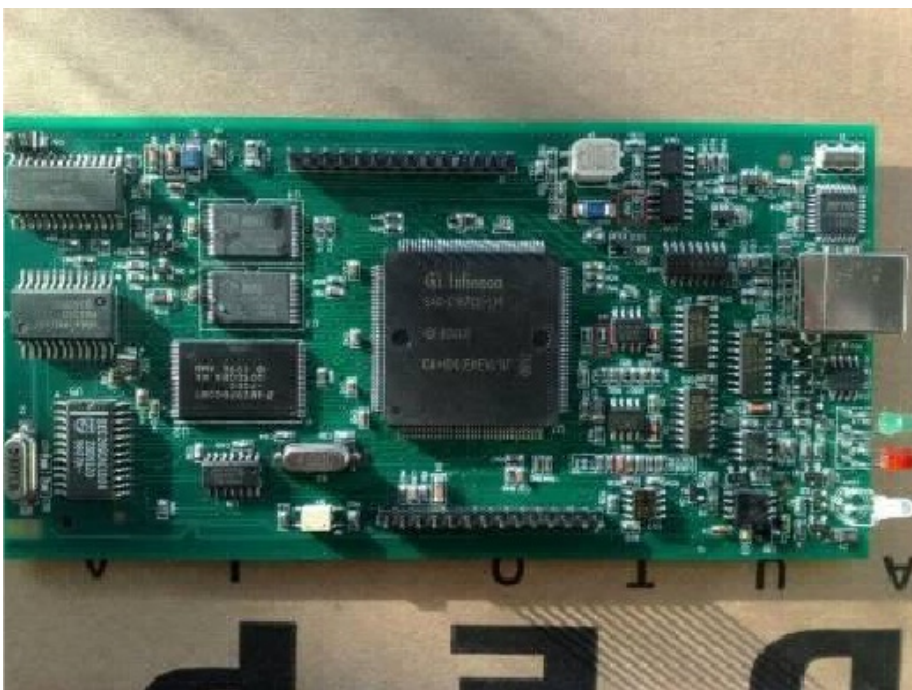
9. check resistor **R58** and capacitors **C11** and **C5** (different between working and not working autocom). with **9241A** diagram you can see that K line need resistor to Vbat (this is **500ohm** on both autocom) and capacitor to GND (measured this capacitance in circuit and on **working AC** is **40nF** and on **non working AC** is **100nF**) or change **C11** to **102pF = 1nF**

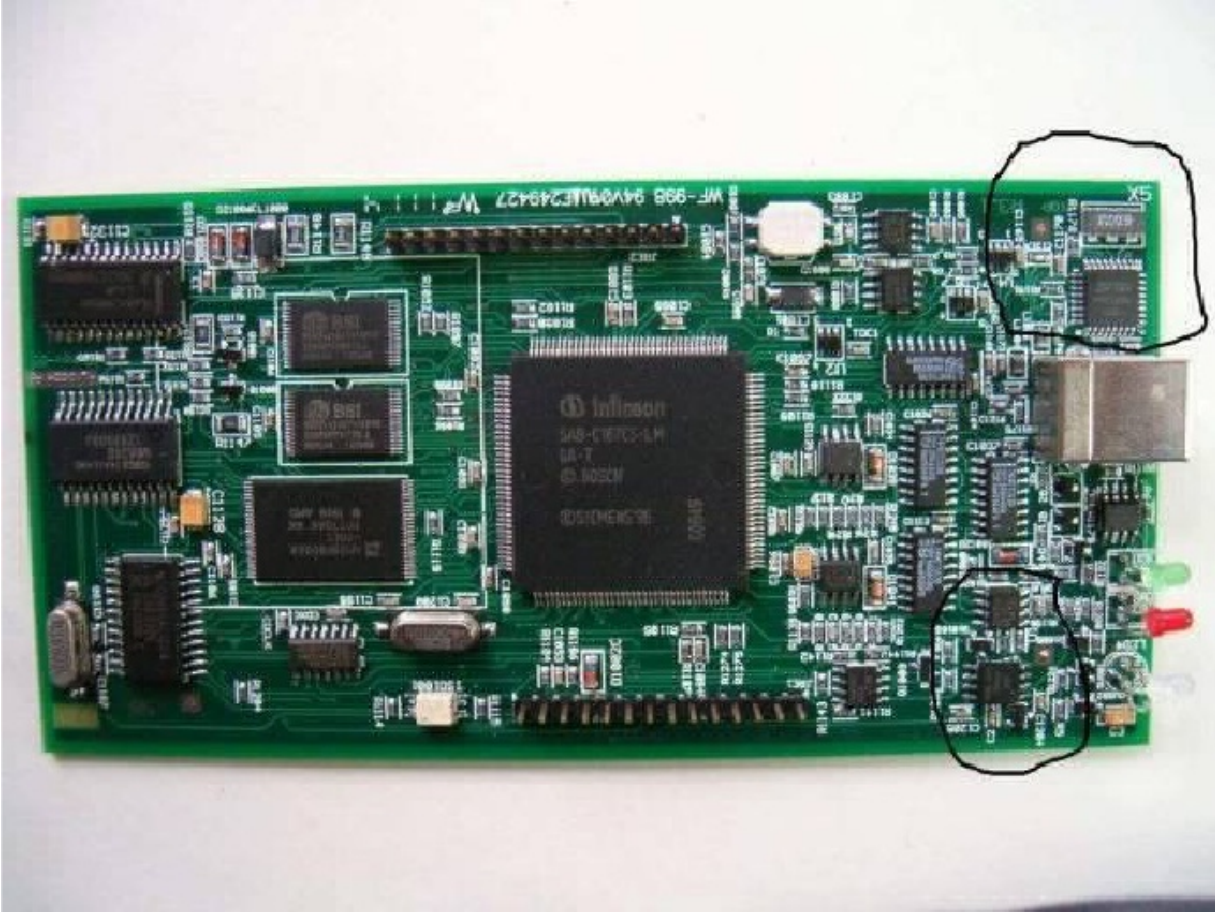
10. solder some surface of pcb with hot air
